RE: LYNNWOOD RECREATION CENTER NATATORIUM

Location of Loss	: 18900 44 <sup>th</sup> Avenue West, Lynnwood, Washington
Date of Loss	: January 1, 2011 (Reported)
Affiliated FM Insurance Company Claim ID	: 425958
Thornton Tomasetti No.	: G13106.00

**APPENDIX A: PHOTO REPORT**

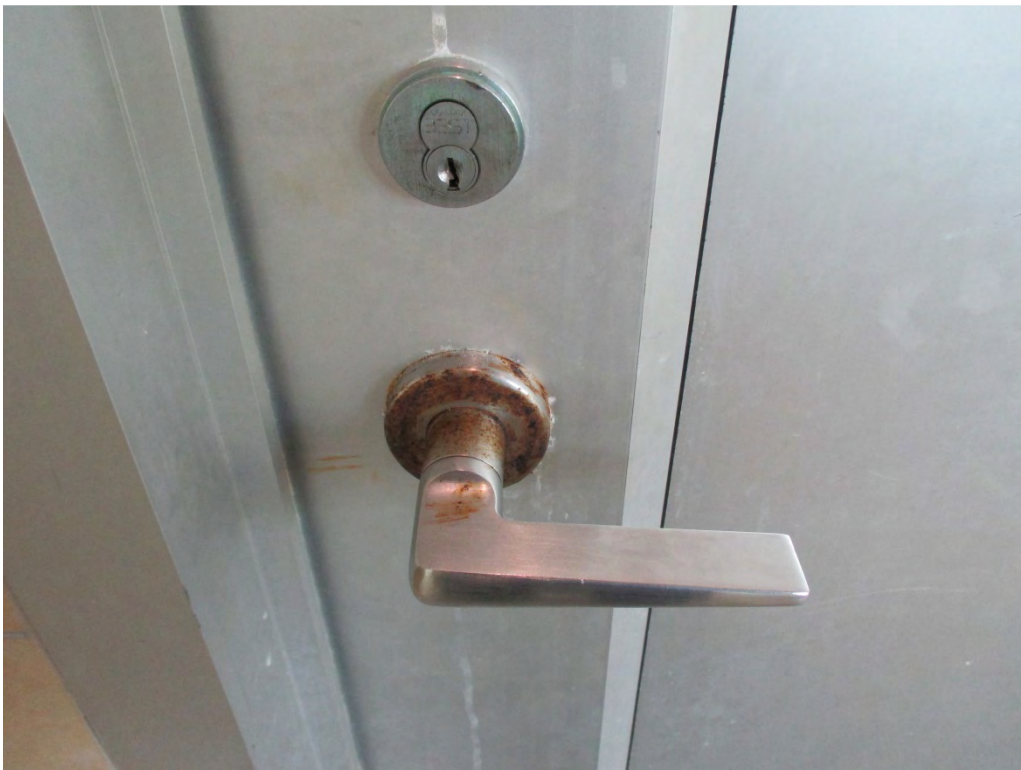
- Corroded door hardware in pool rooms (Photos 2 and 3) and adjacent office (Photo 4)
- Corroded fasteners at connections in pool room (Photo 5) and stairway (Photo 6)
- Fasteners at interior pool equipment connections (Photo 7) exhibited a much higher level of corrosion than similar connections at exterior pool equipment connections (Photo 8)
- Deteriorated roofing materials (Photos 9 and 10)

Photo 2: Corrosion at door handle

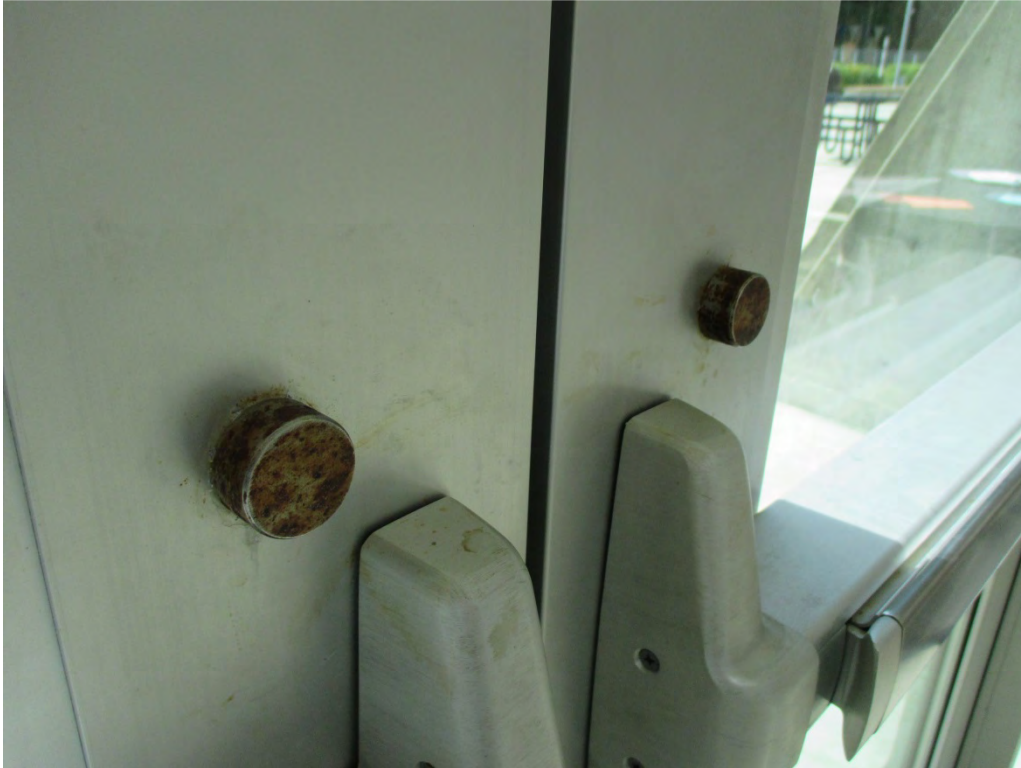
Photo 3: Corrosion at door

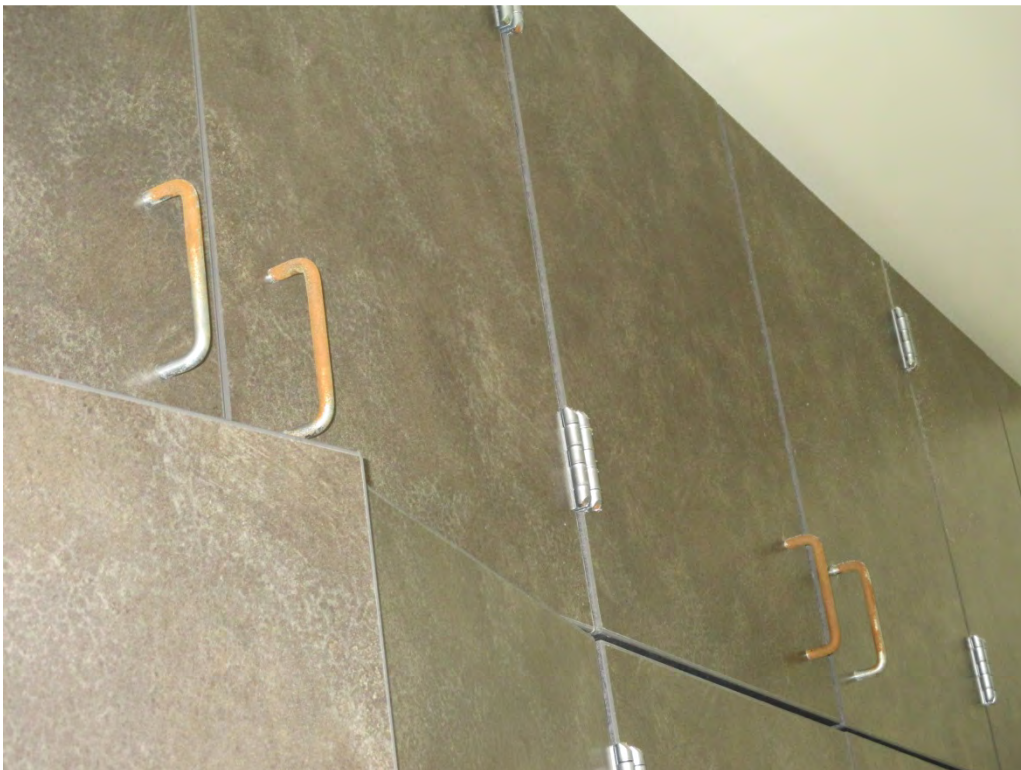
Photo 4: Corrosion at cabinet handles

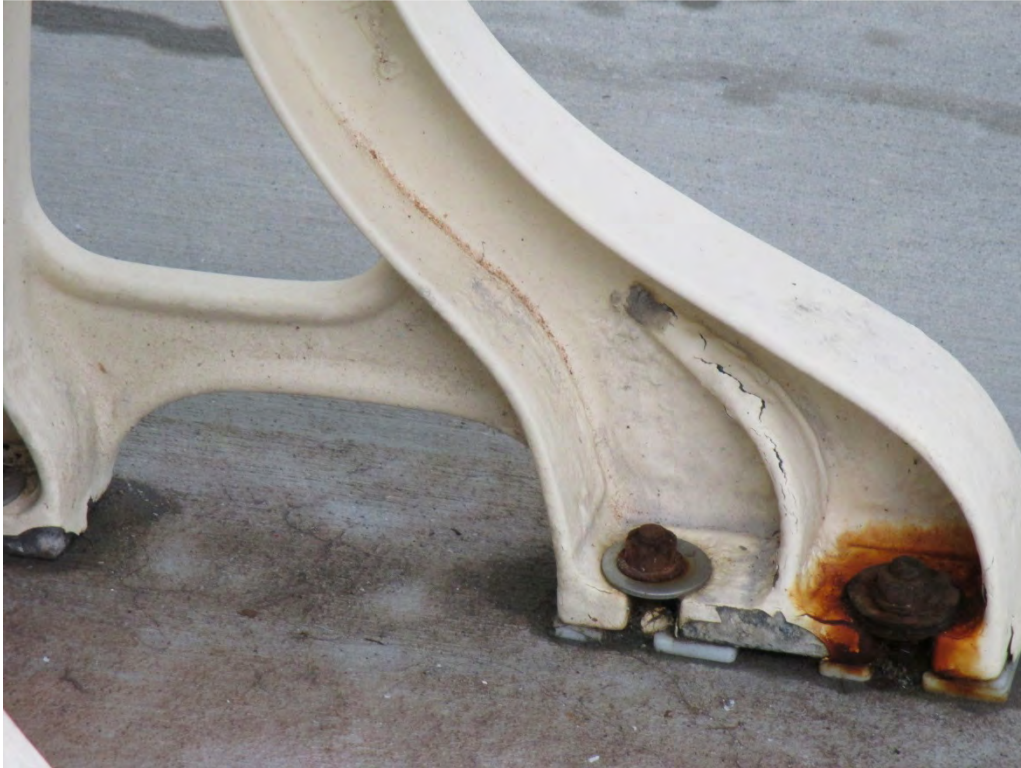
Photo 5: Corrosion at pool equipment anchorage

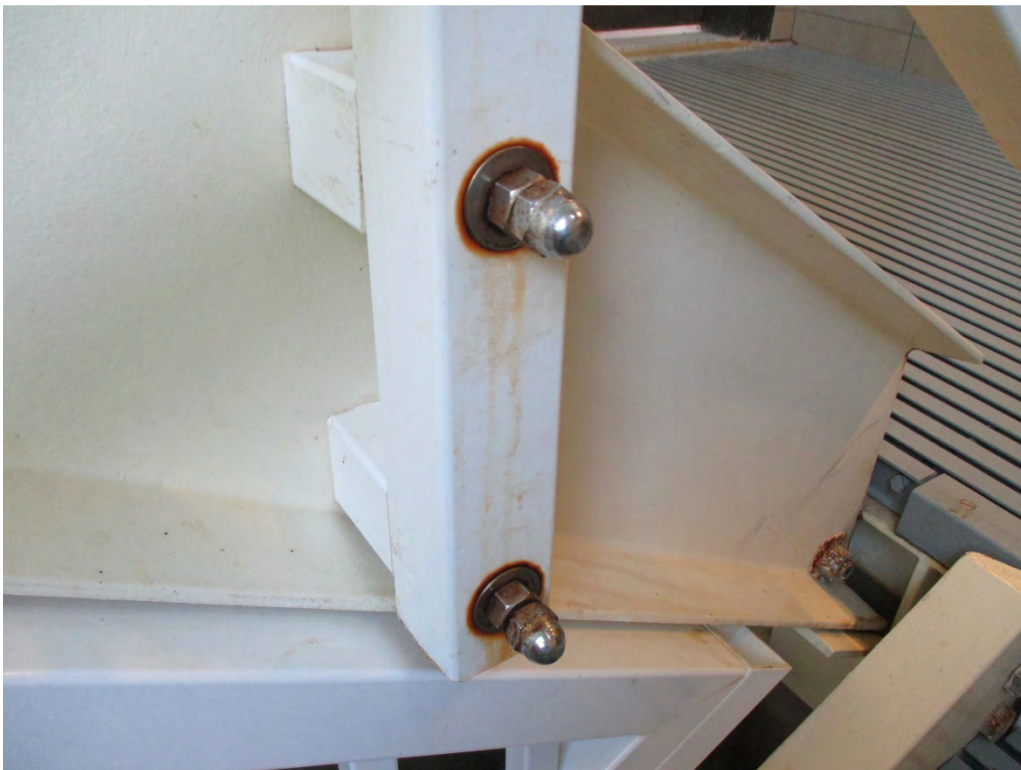
Photo 6: Corrosion at stair railing

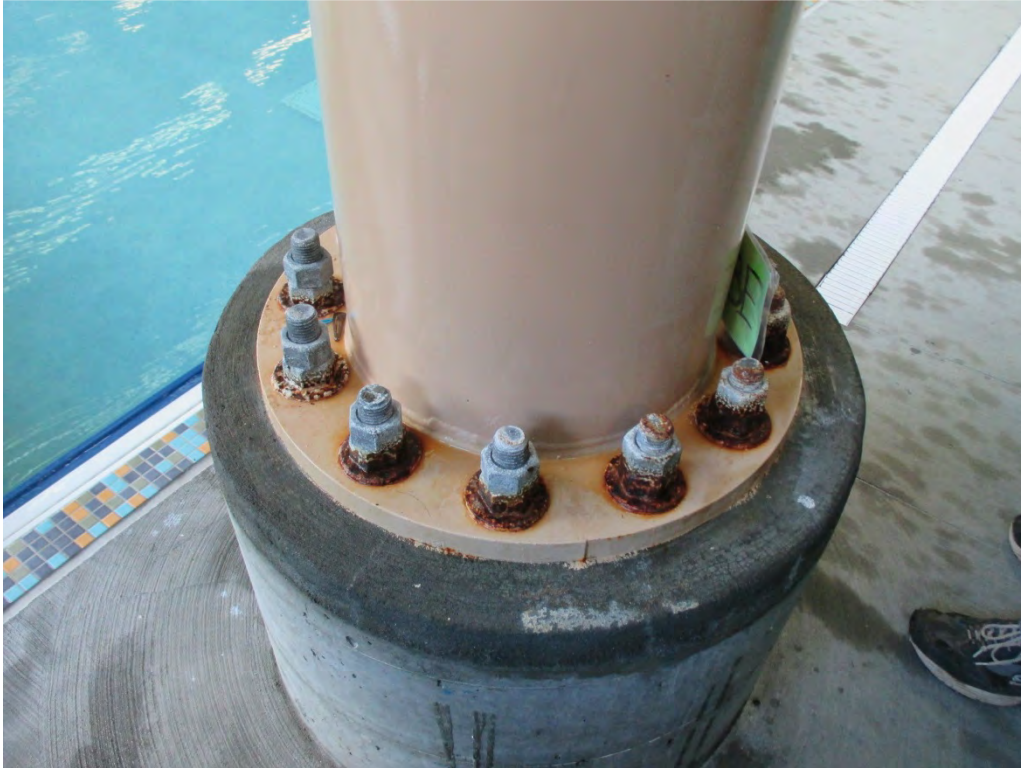
Photo 7: Corrosion at column fasteners inside the natatorium

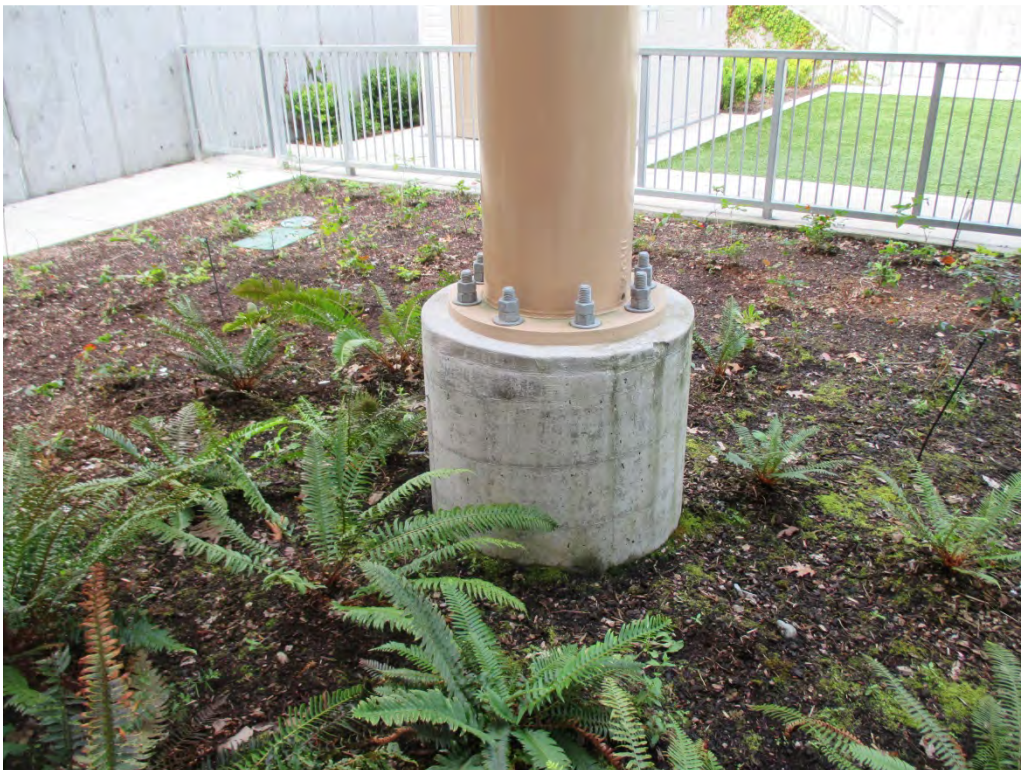
Photo 8: Column fasteners outside of the natatorium

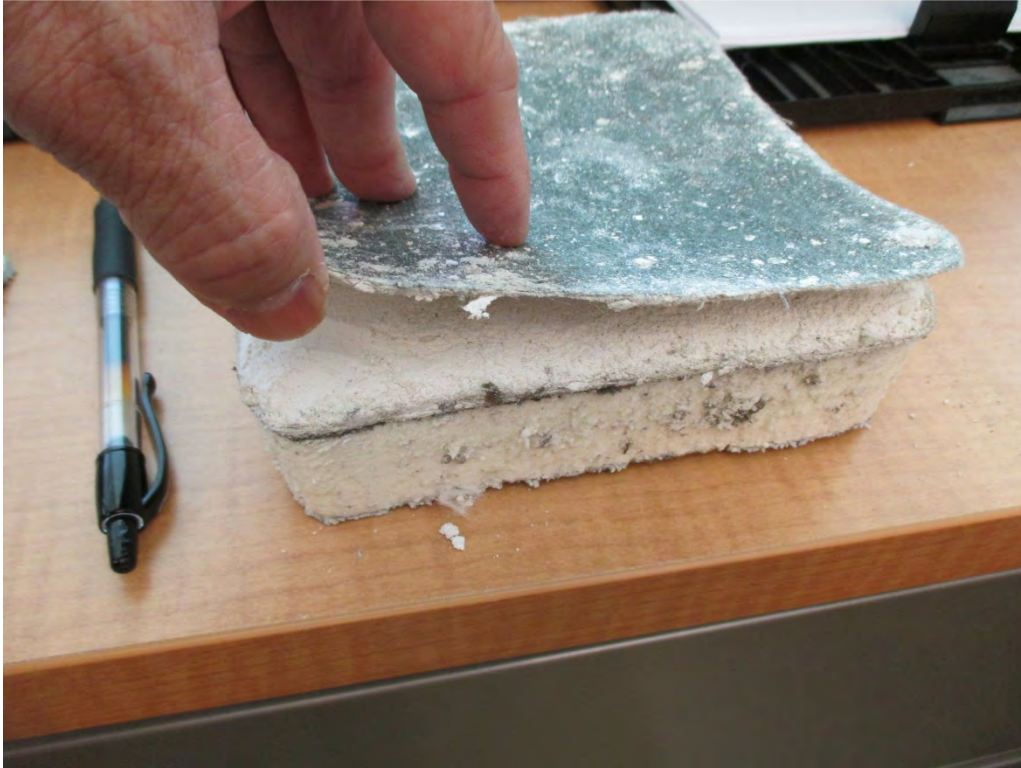
The source of the moisture in the roof is also evaporated water from the pool. Investigations conducted to date indicate that the vapor barrier specified in the construction drawings was not installed. Without the vapor barrier, the moisture can accumulate in the roof assembly and condense which has caused the deterioration of the roofing materials and the mold growth.

Photo 9: Deterioration at roofing assembly

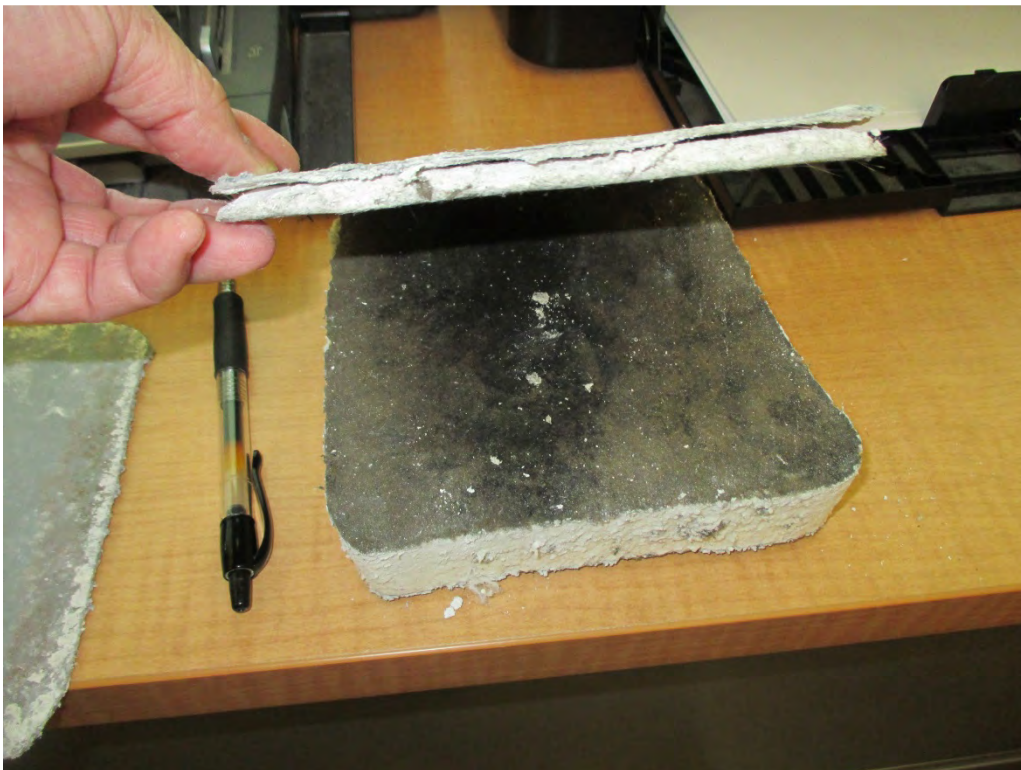
Photo 10: Deterioration at roofing assembly

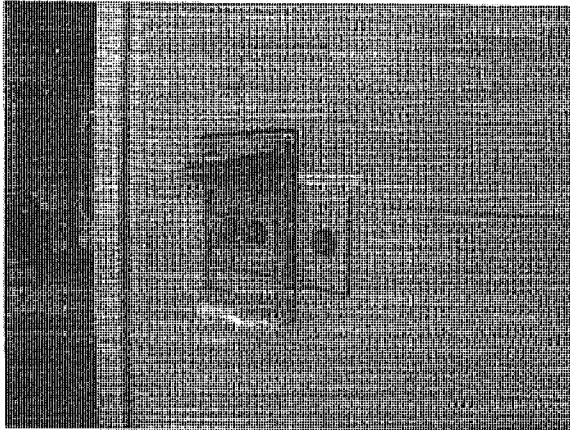
Figure 9. Corrosion on control buttons, cover was added to minimize damage

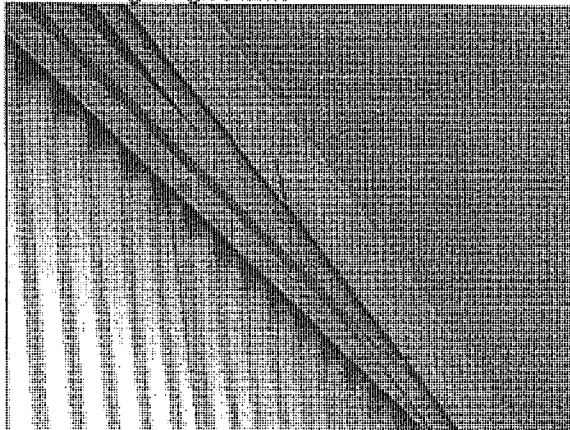
Figure 13. Corrosion of building materials evident on exterior from previous chlorine and moisture laden air leakage

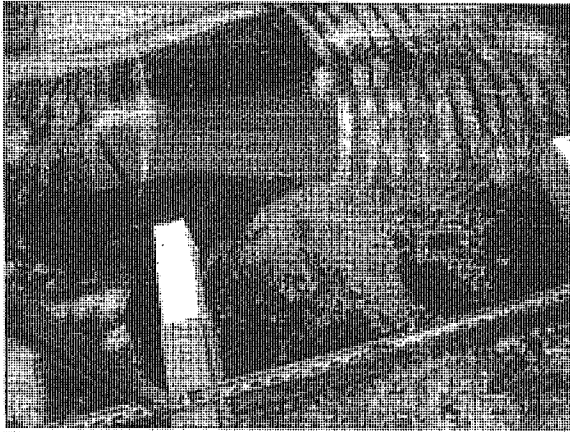
Figure 15. Ponding on roof near mechanical units

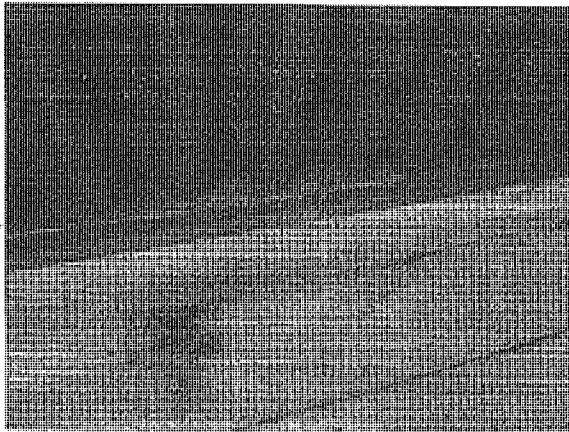
Figure 21. Evidence of in-wall corrosion being pushed out by previously positive natatorium pressure

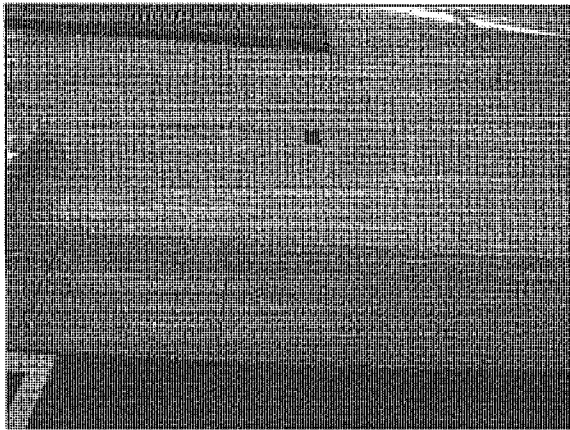
Figure 27. Corrosion on junction box cover

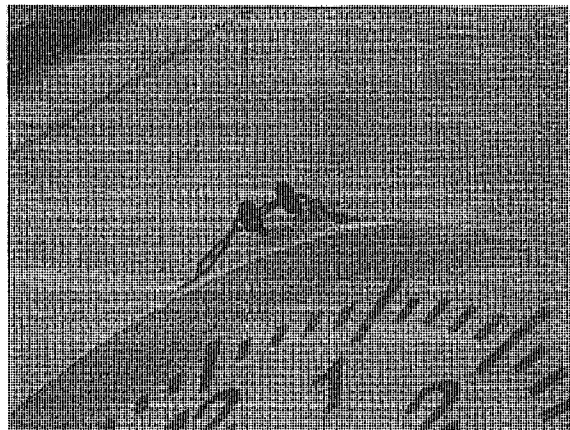
Figure 28. Corrosion on eye bolts and chain holding up clock

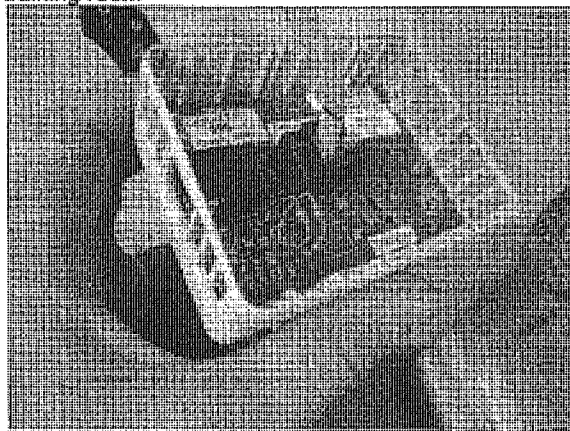
Figure 41. Corrosion on electronic components in wall sensor in staff training room

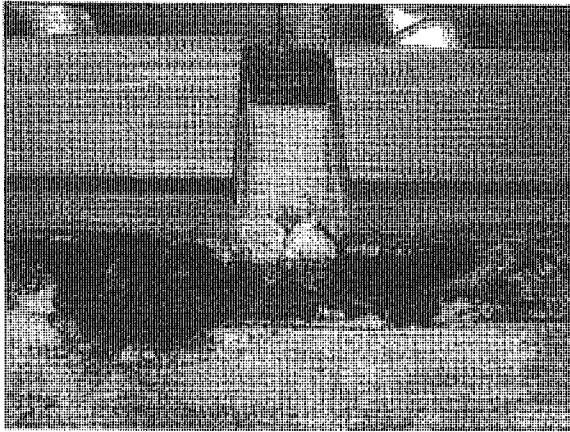
Figure 45. Scupper on high roof above boiler room/slide loading is a possible source for the unknown moisture damage in the boiler room

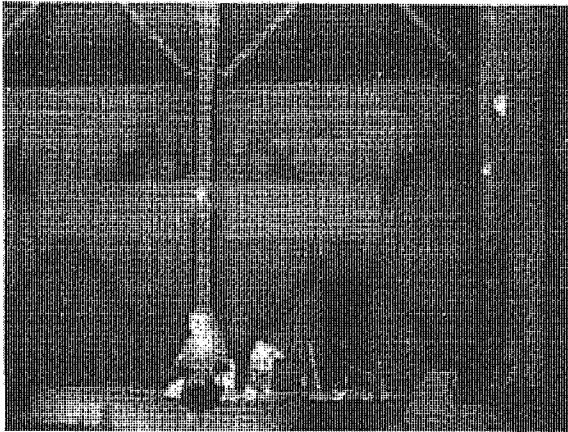
Figure 61. Infrared showing thermal bridging and air leakage

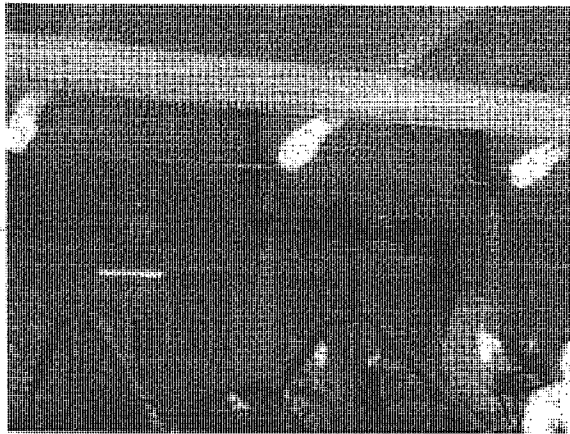
Figure 64. Infrared showing air leakage at the glu-lam/wall interface

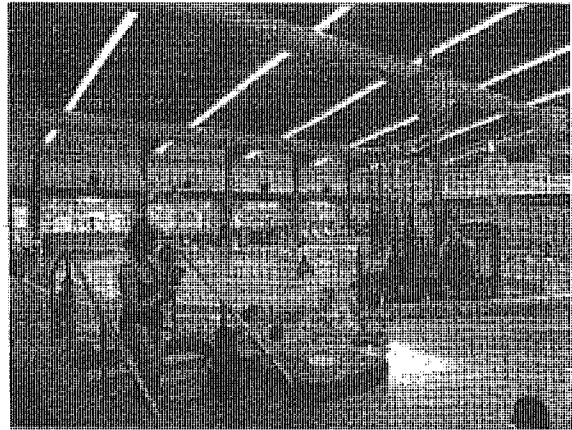
Figure 65. Infrared showing air leakage at the glu-lam/wall interface

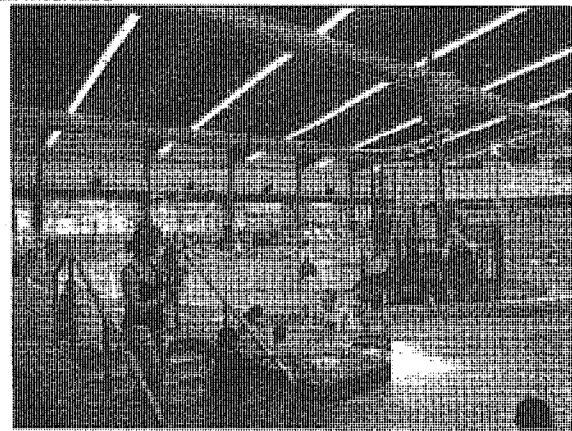
Figure 66. Infrared showing air leakage at the glu-lam/wall interface

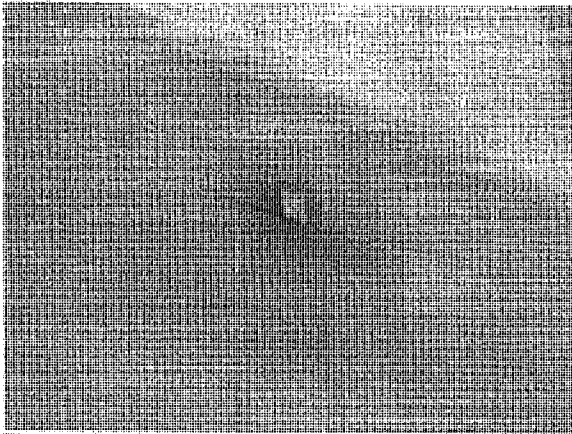
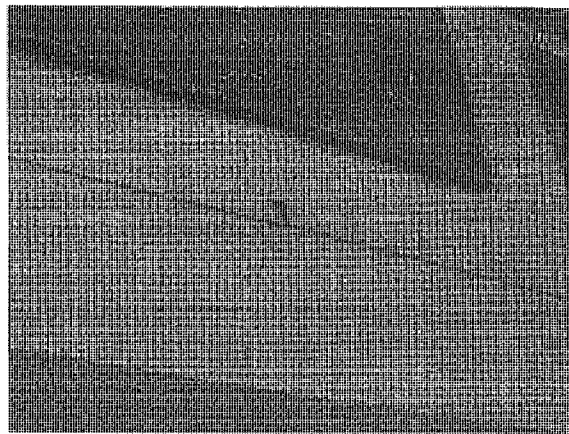
Figure 70. Infrared showing air leakage at junction box cover

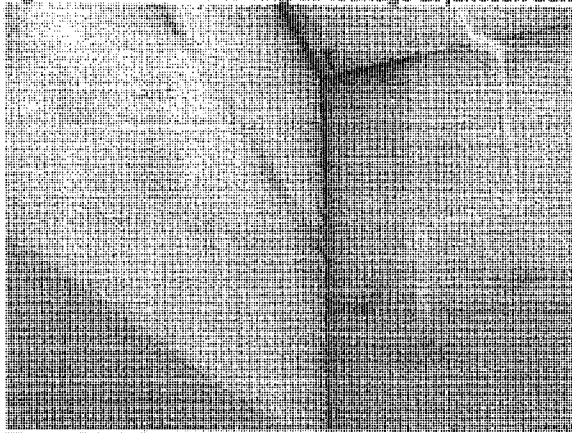
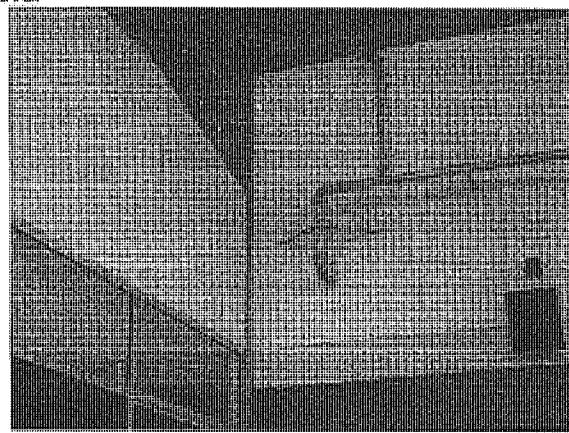
Figure 71. Infrared showing air leakage at the corner

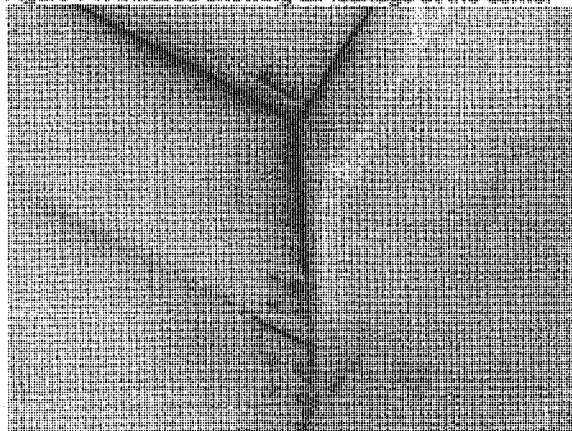
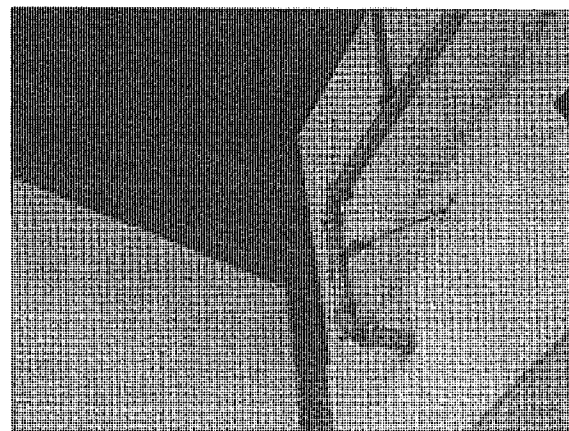
Figure 72. Infrared showing air leakage at the corner

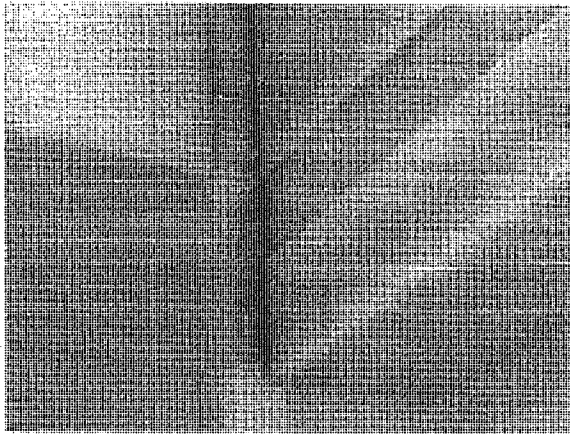
Figure 73. Infrared showing air leakage at the corner

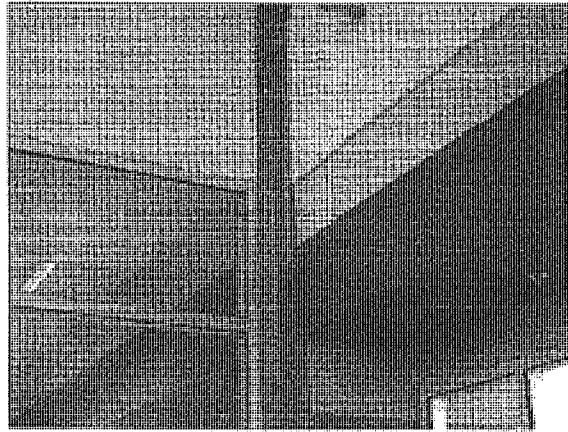
Figure 74. Infrared showing air leakage at wall to column/moist/ceiling interface

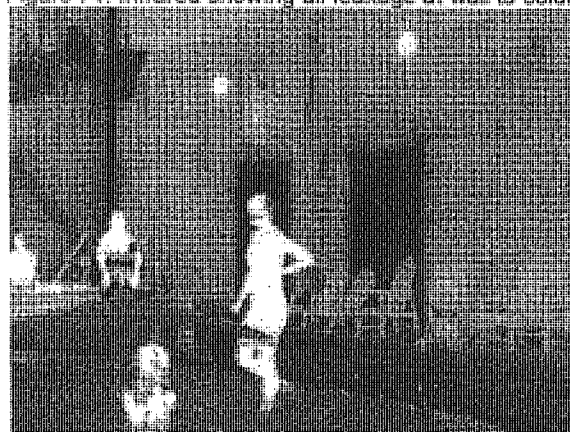
Figure 75. Infrared showing air leakage at windows and possible moisture loading in wall

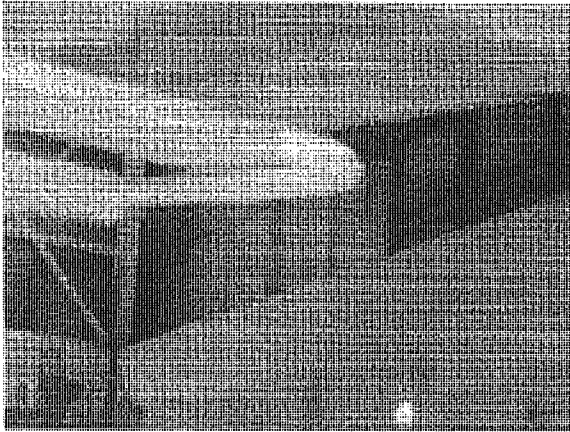
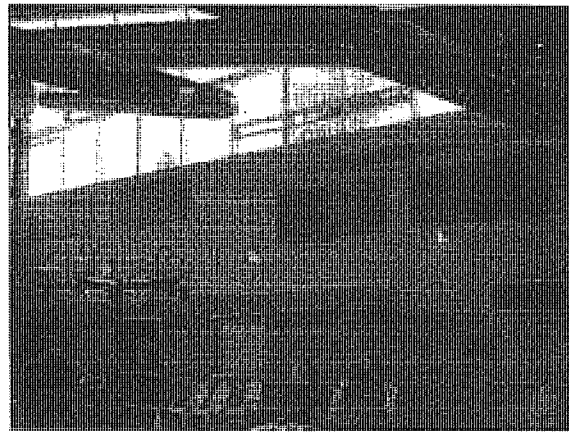
Figure 76. Infrared showing air leakage at windows and possible moisture loading in wall

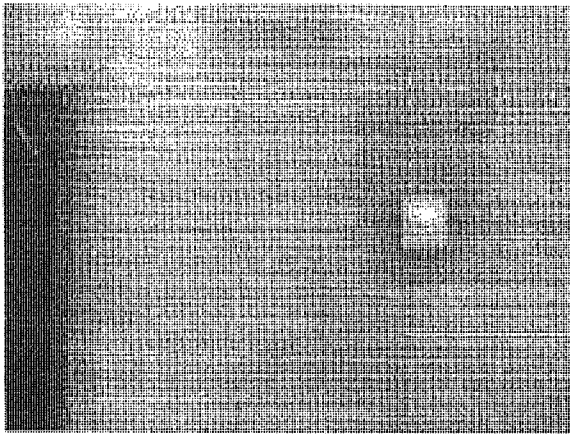
Figure 79. Infrared showing minor air leakage at wall mounted sensor

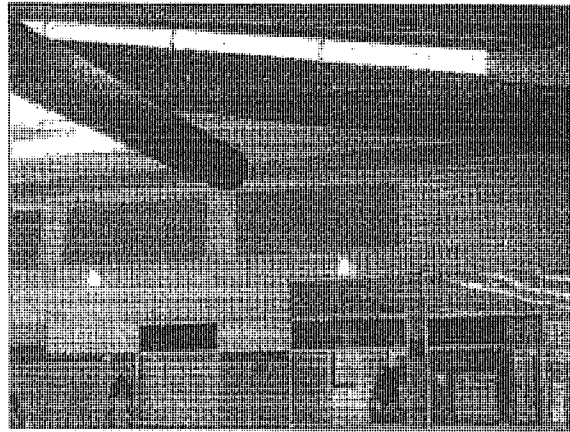
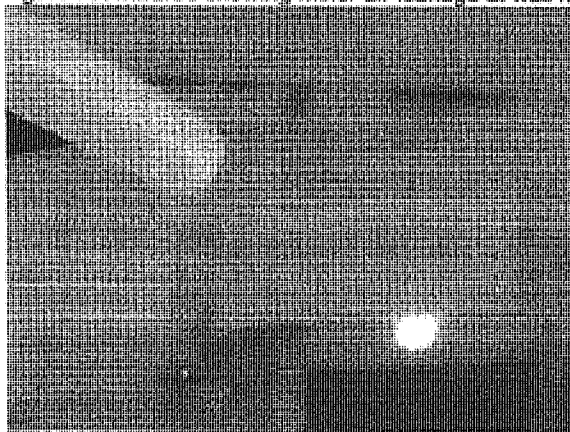
Figure 80. Infrared showing air leakage at windows and wall-to-ceiling transition and possible moisture loading in wall

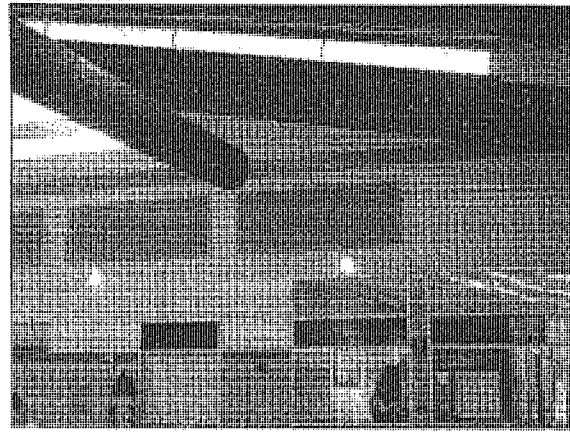
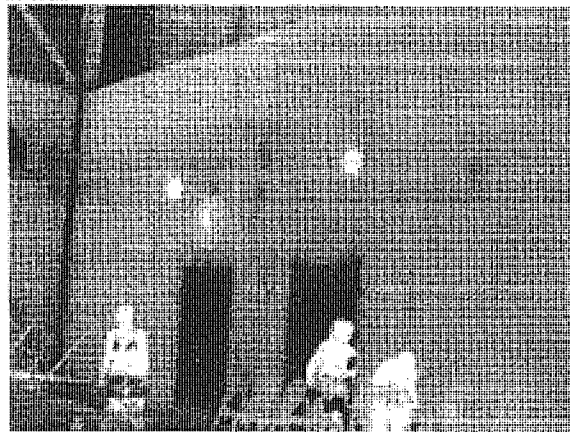
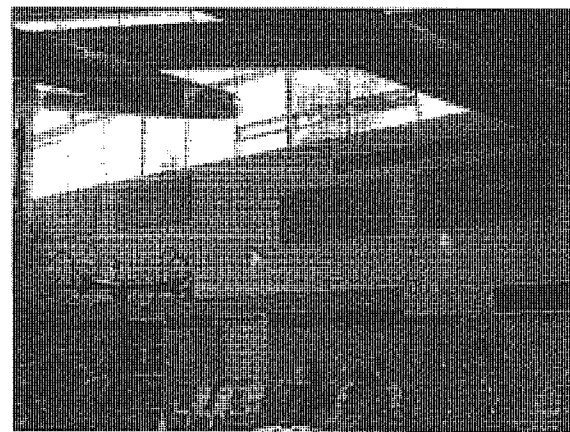
Figure 81. Infrared showing air leakage at windows and possible moisture loading in wall

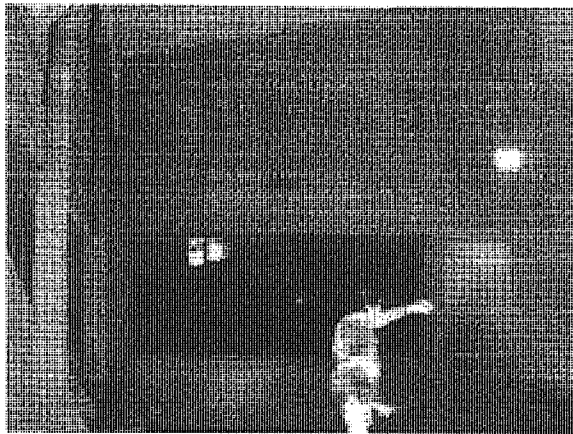
Figure 82. Infrared showing air leakage at corner and wall mounted sensor

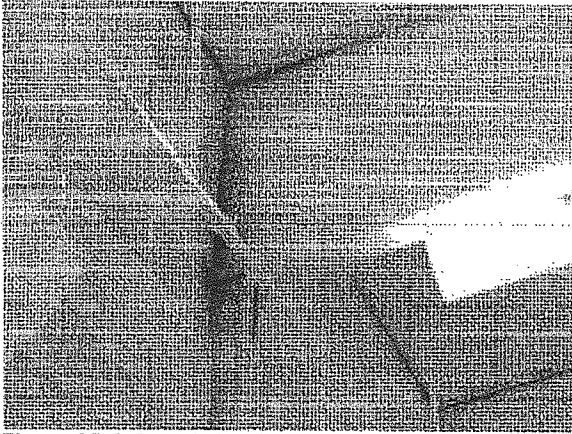
Figure 85. Infrared showing air leakage at wall to column/joist/ceiling interface

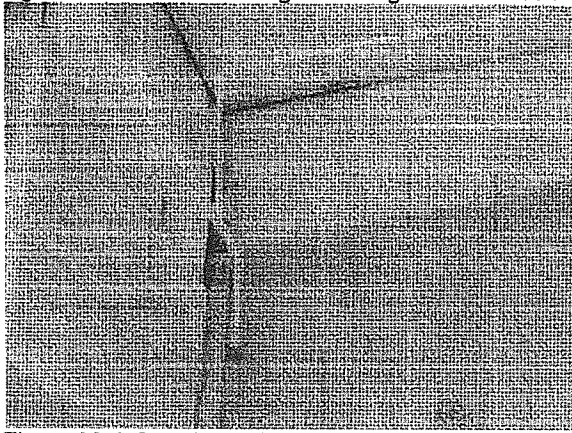
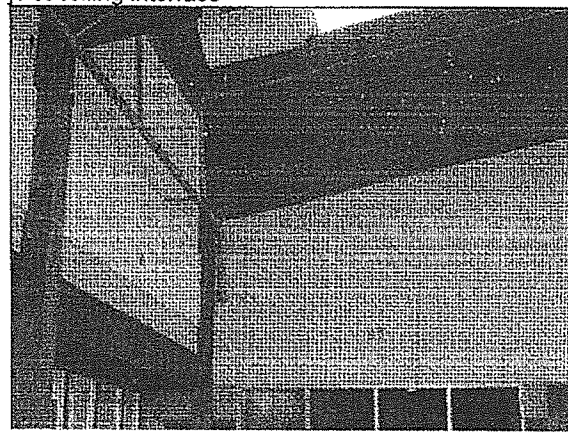
Figure 86. Infrared showing air leakage at wall to column/joist/ceiling interface

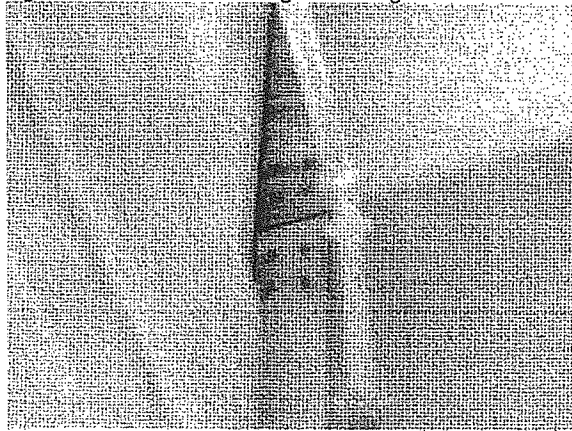
Figure 87. Infrared showing air leakage at wall to column/joist interface

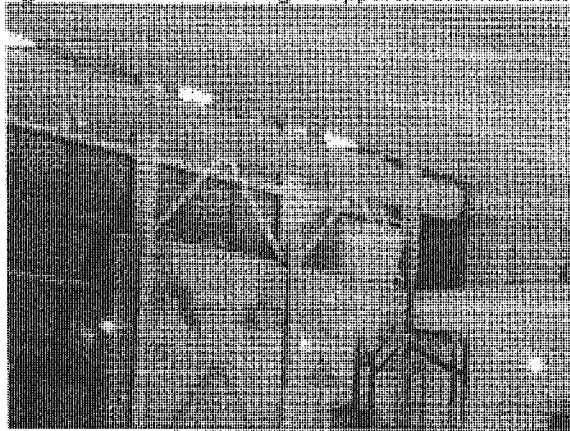
Figure 92. Infrared showing thermal bridging and air leakage in wall

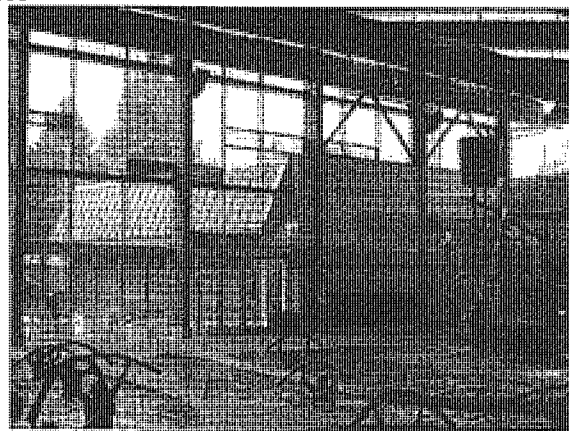
Figure 93. Infrared showing thermal bridging and air leakage in wall

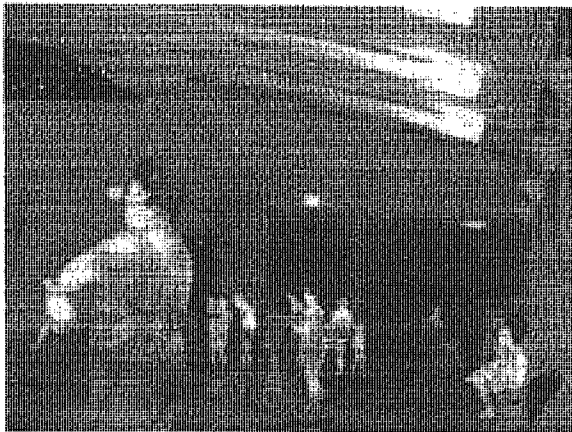
Figure 94. Infrared showing air leakage at wall to ceiling transition

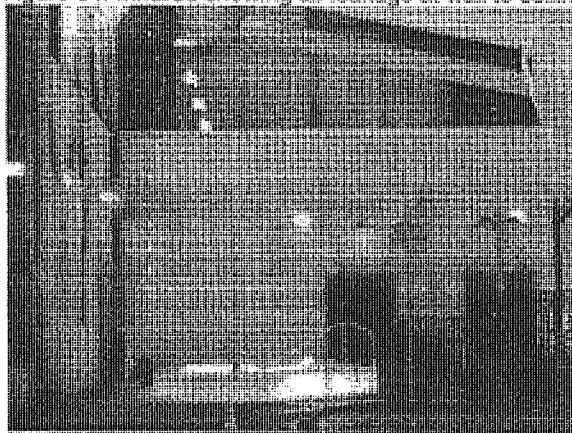
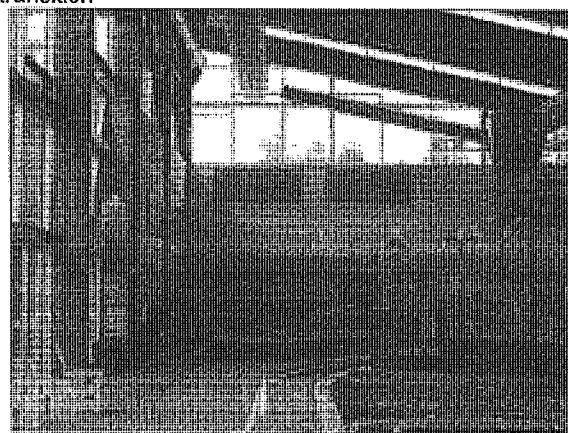
Figure 95. Infrared showing air leakage at windows and thermal bridging/possible moisture loading in the wall

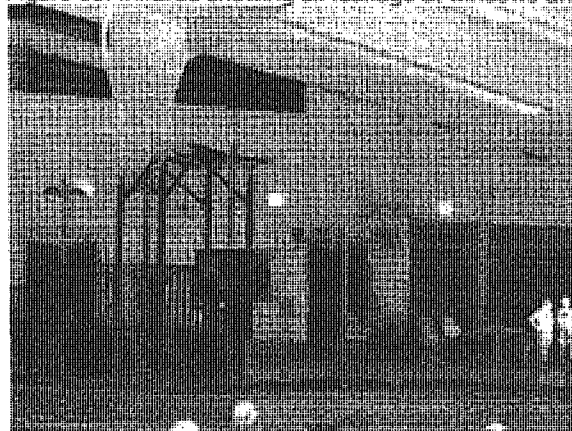
Figure 96. Infrared showing air leakage at windows and wall to ceiling transition as well as thermal bridging in the wall

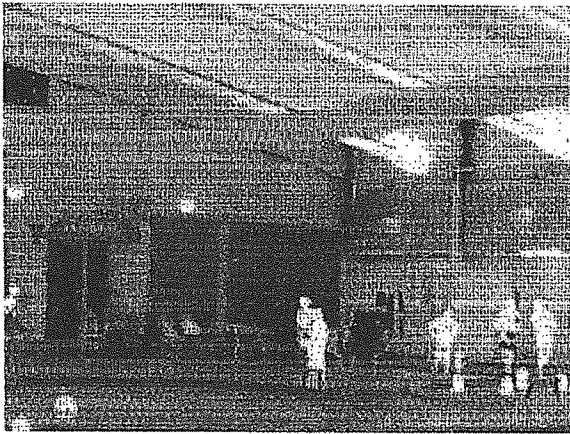
Figure 97. Infrared showing air leakage at columns, joists, wall to ceiling transitions, and windows

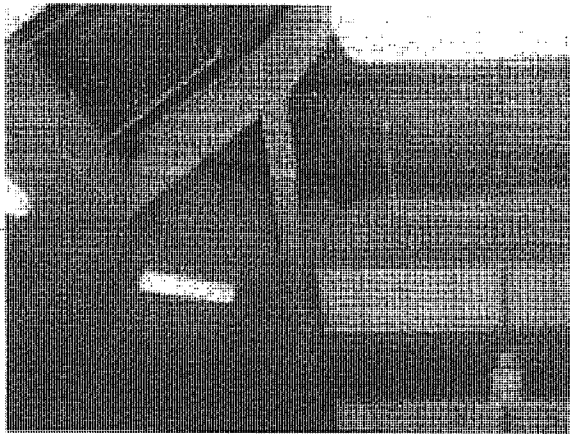
Figure 100. Infrared showing thermal bridging at translucent panel as well as moisture loading in wall below due to condensation from above

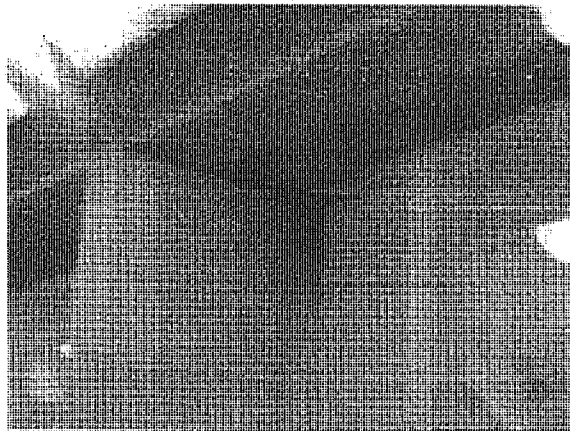
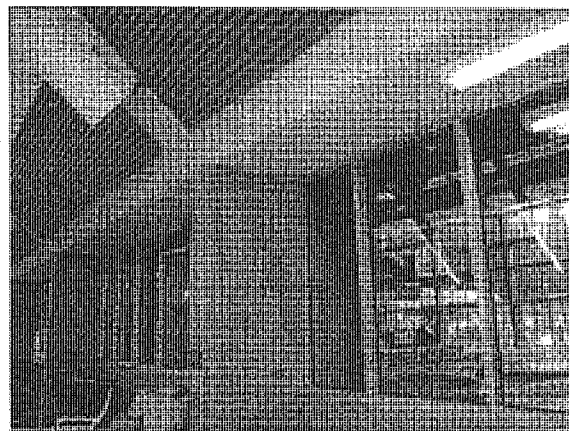
Figure 101. Infrared showing air leakage at column to ceiling/wall transition

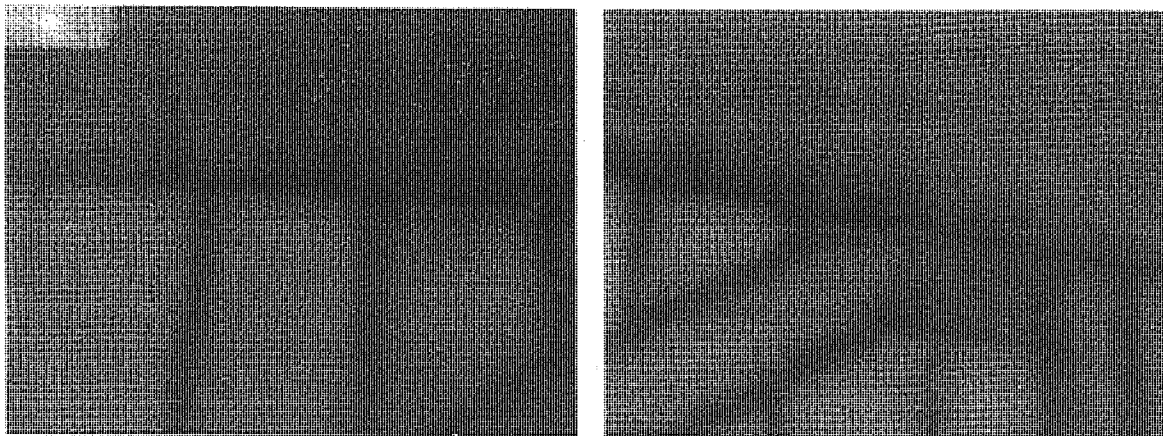
Figure 109. Infrared images showing thermal bridging and air leakage in wall in slide loading area

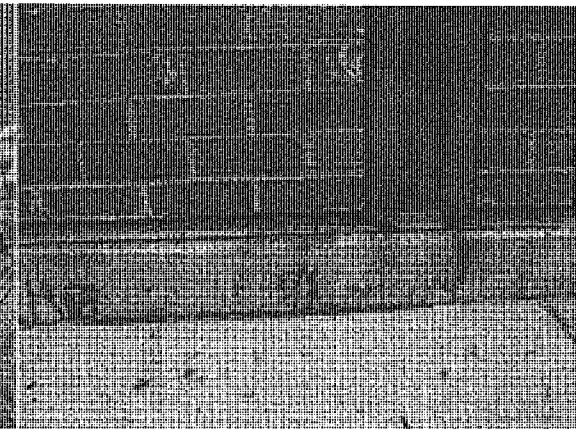
Figure 2. Moisture weeping from the base of the brick veneer system

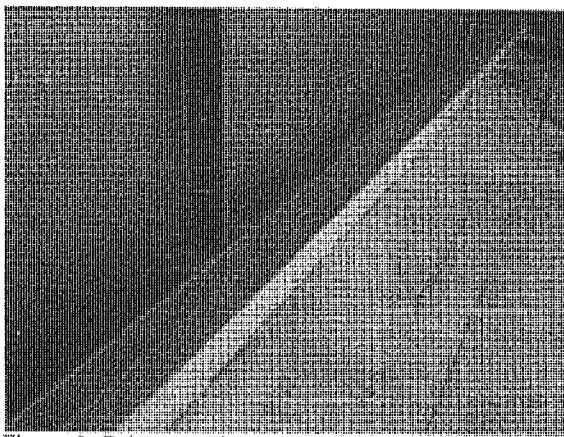
Figure 9. Evidence of past moisture weeping from the base of the metal panel system
